**FINAL PHASE I RFI/RI REPORT
WALNUT CREEK
PRIORITY DRAINAGE
OPERABLE UNIT 6**

**SECTIONS 1.0, 2.0, and 3.0
TEXT, TABLES, AND FIGURES**

**U.S. Department of Energy
Rocky Flats Environmental Technology Site
Golden, Colorado**

February 1996

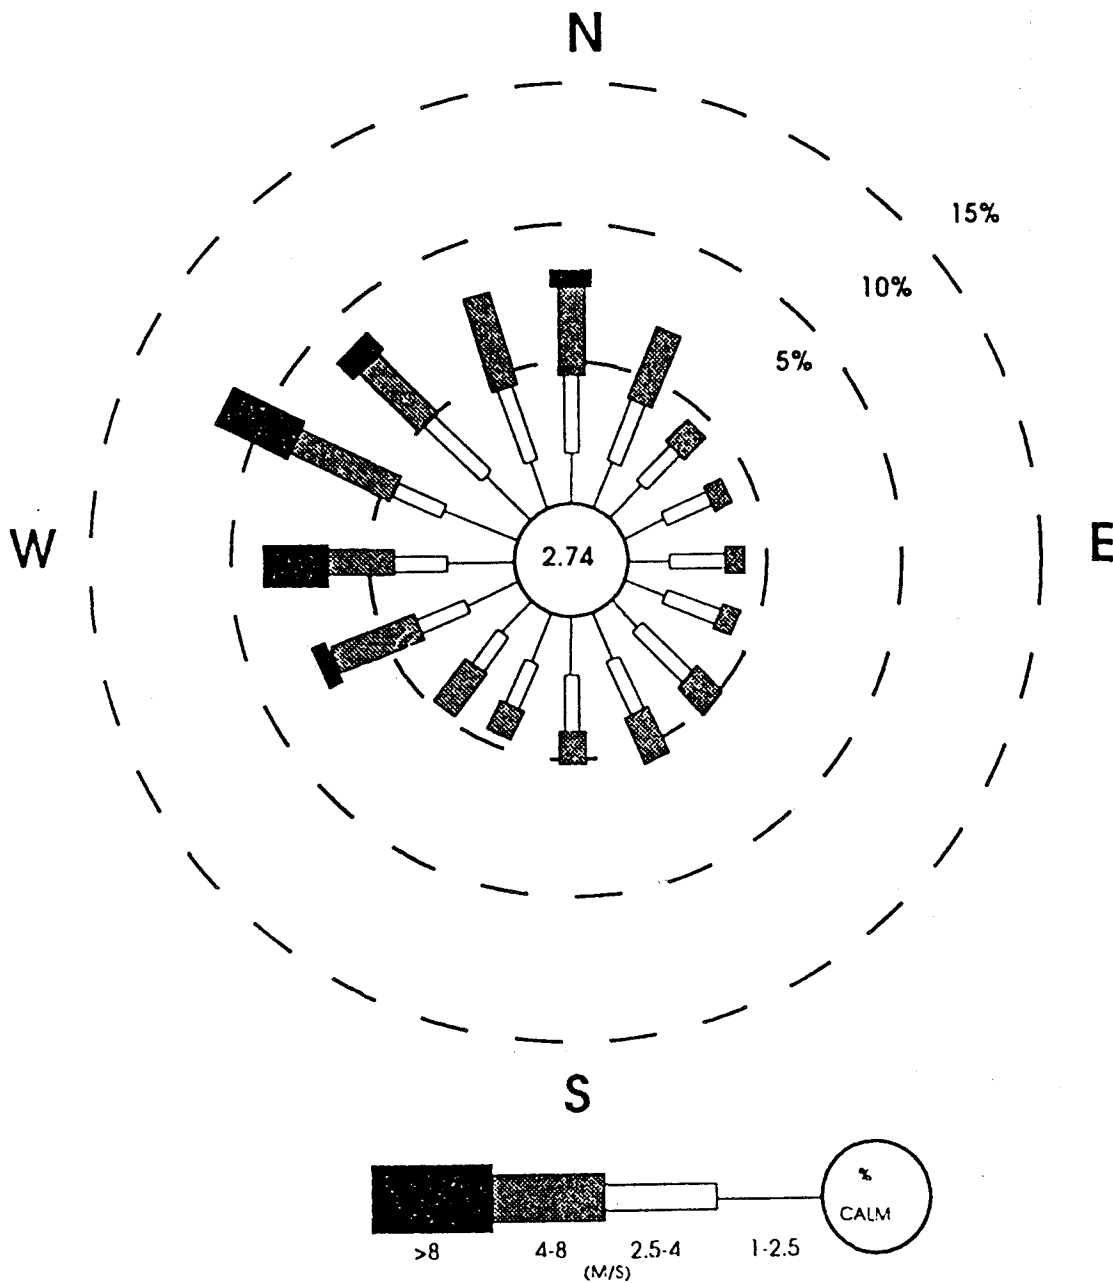
1993 ANNUAL WIND ROSE
FOR THE ROCKY FLATS
ENVIRONMENTAL TECHNOLOGY SITE

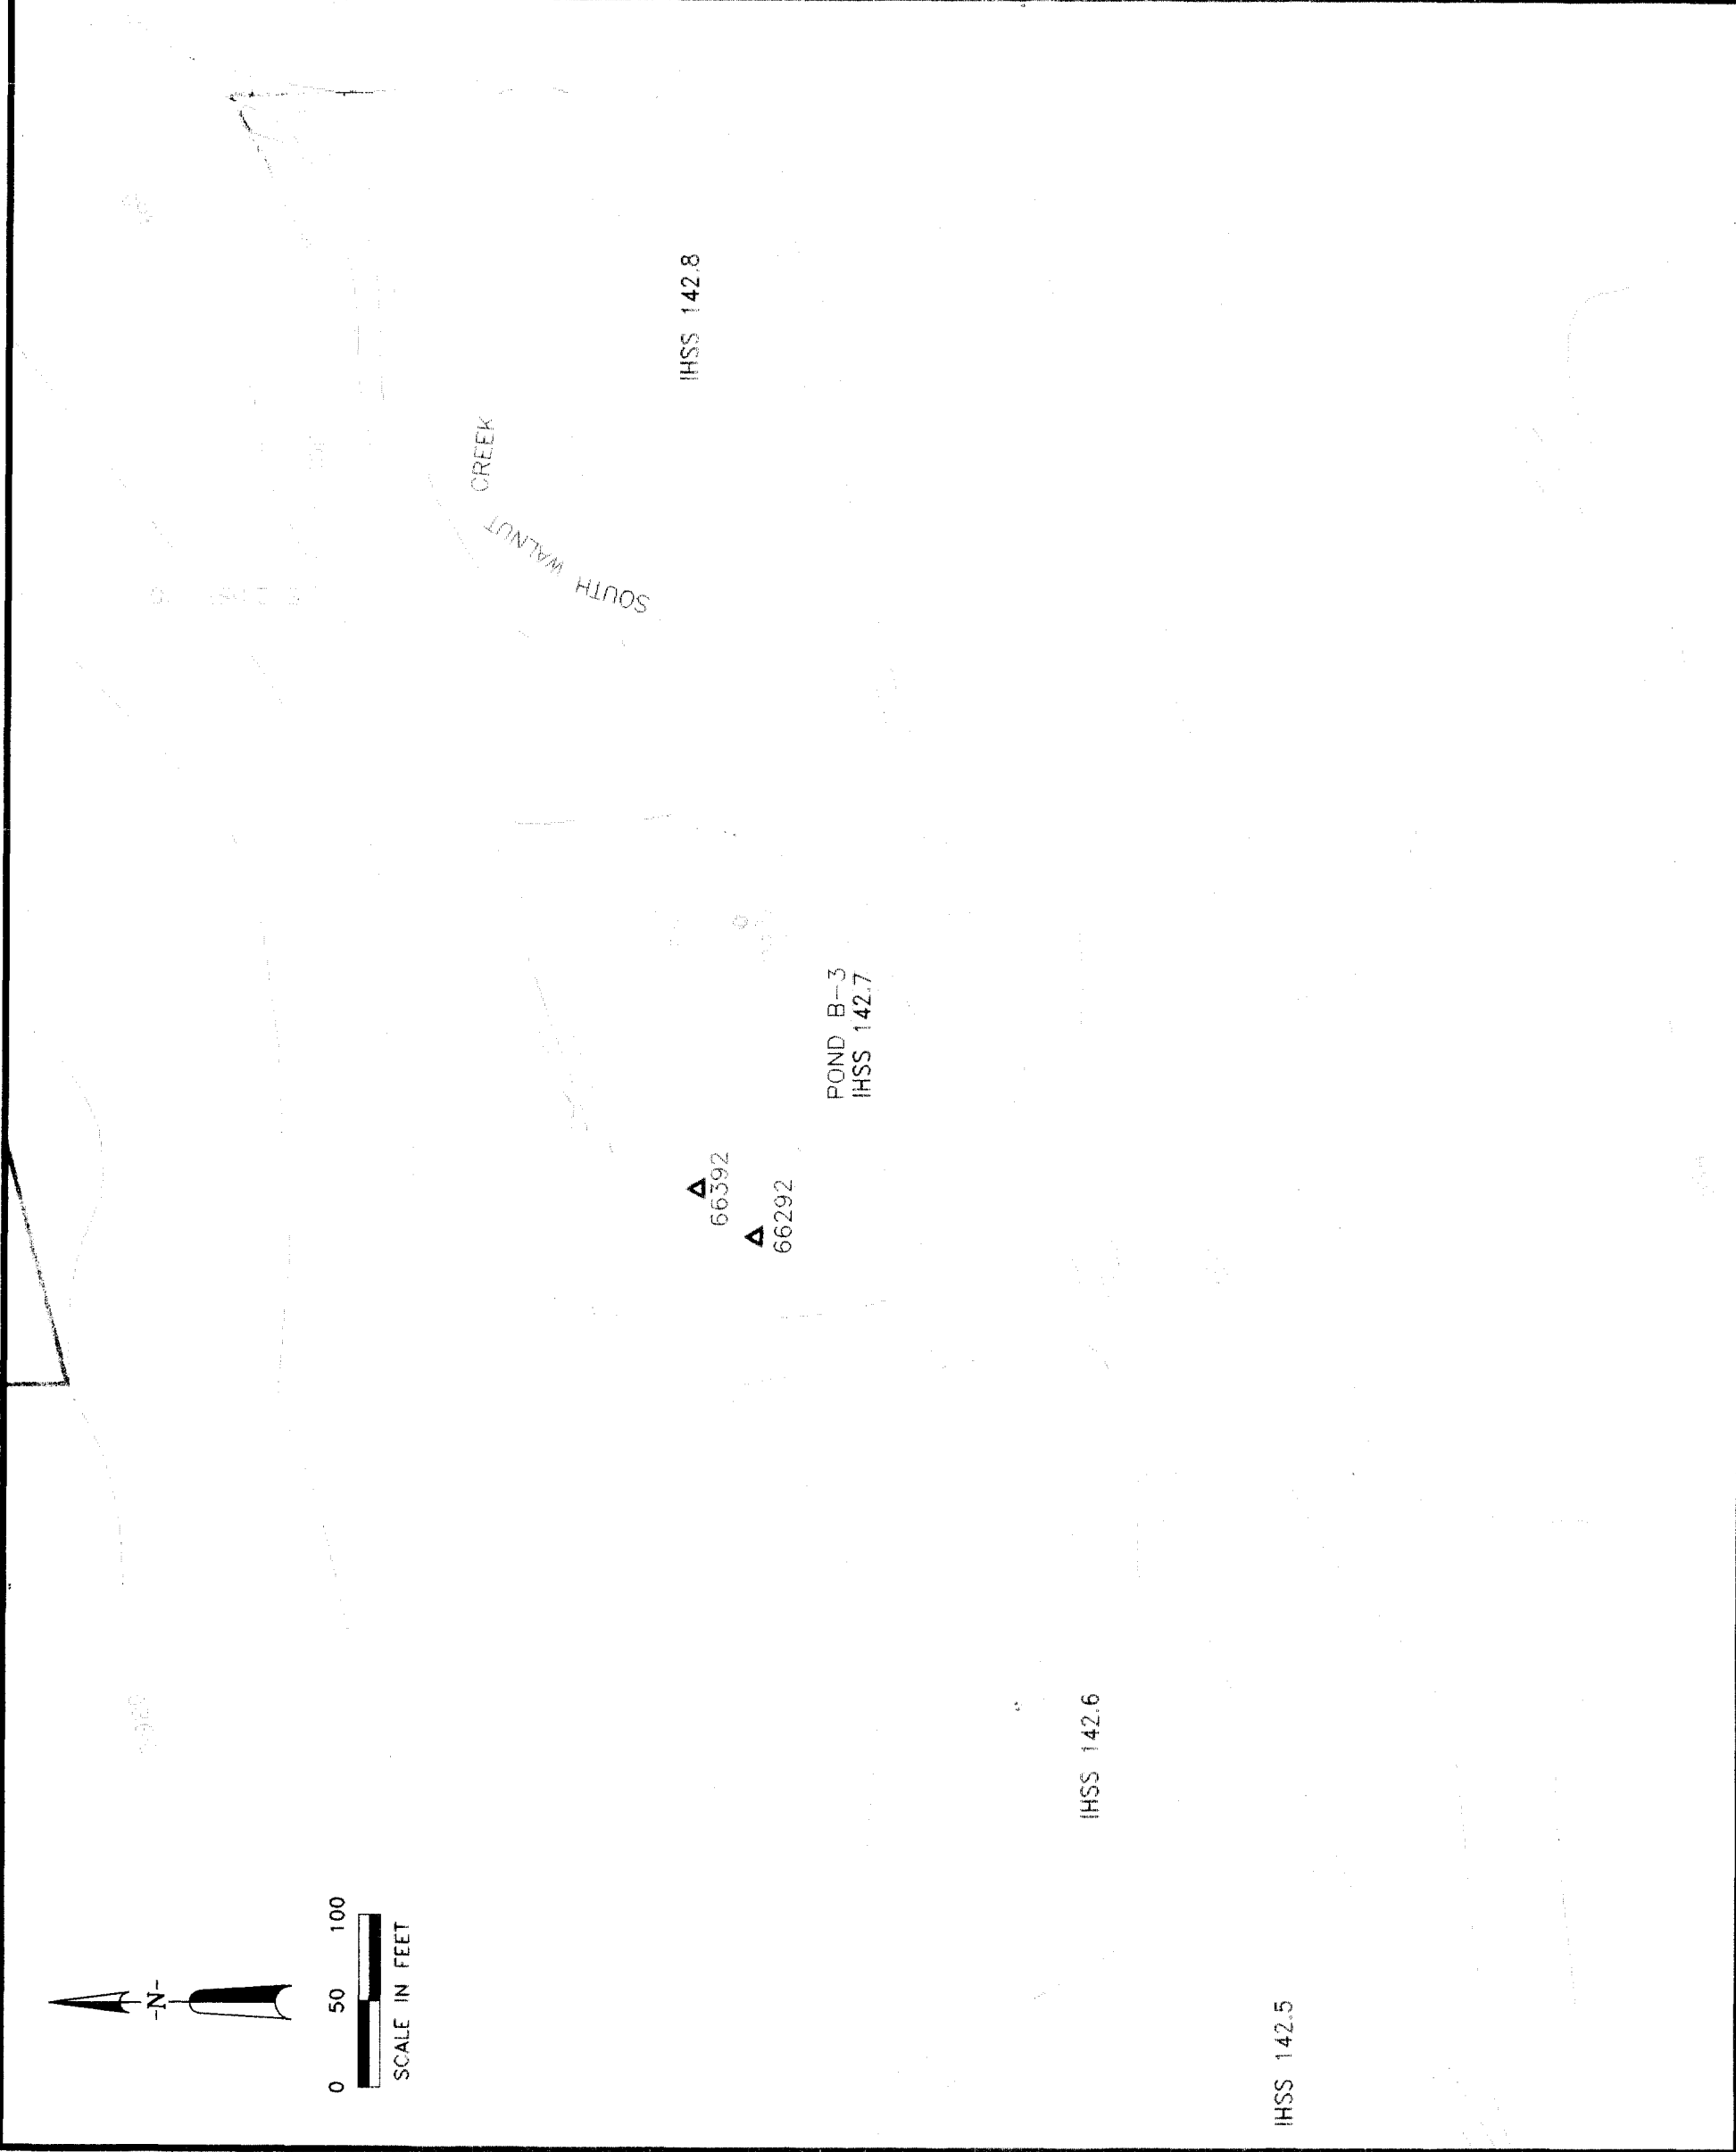
FIGURE 2.2-9 APRIL 1995

SURFACE WATER, WET SEDIMENT,
AND DRY SEDIMENT SAMPLE SITES
POND B-3 (IHSS 142.7)

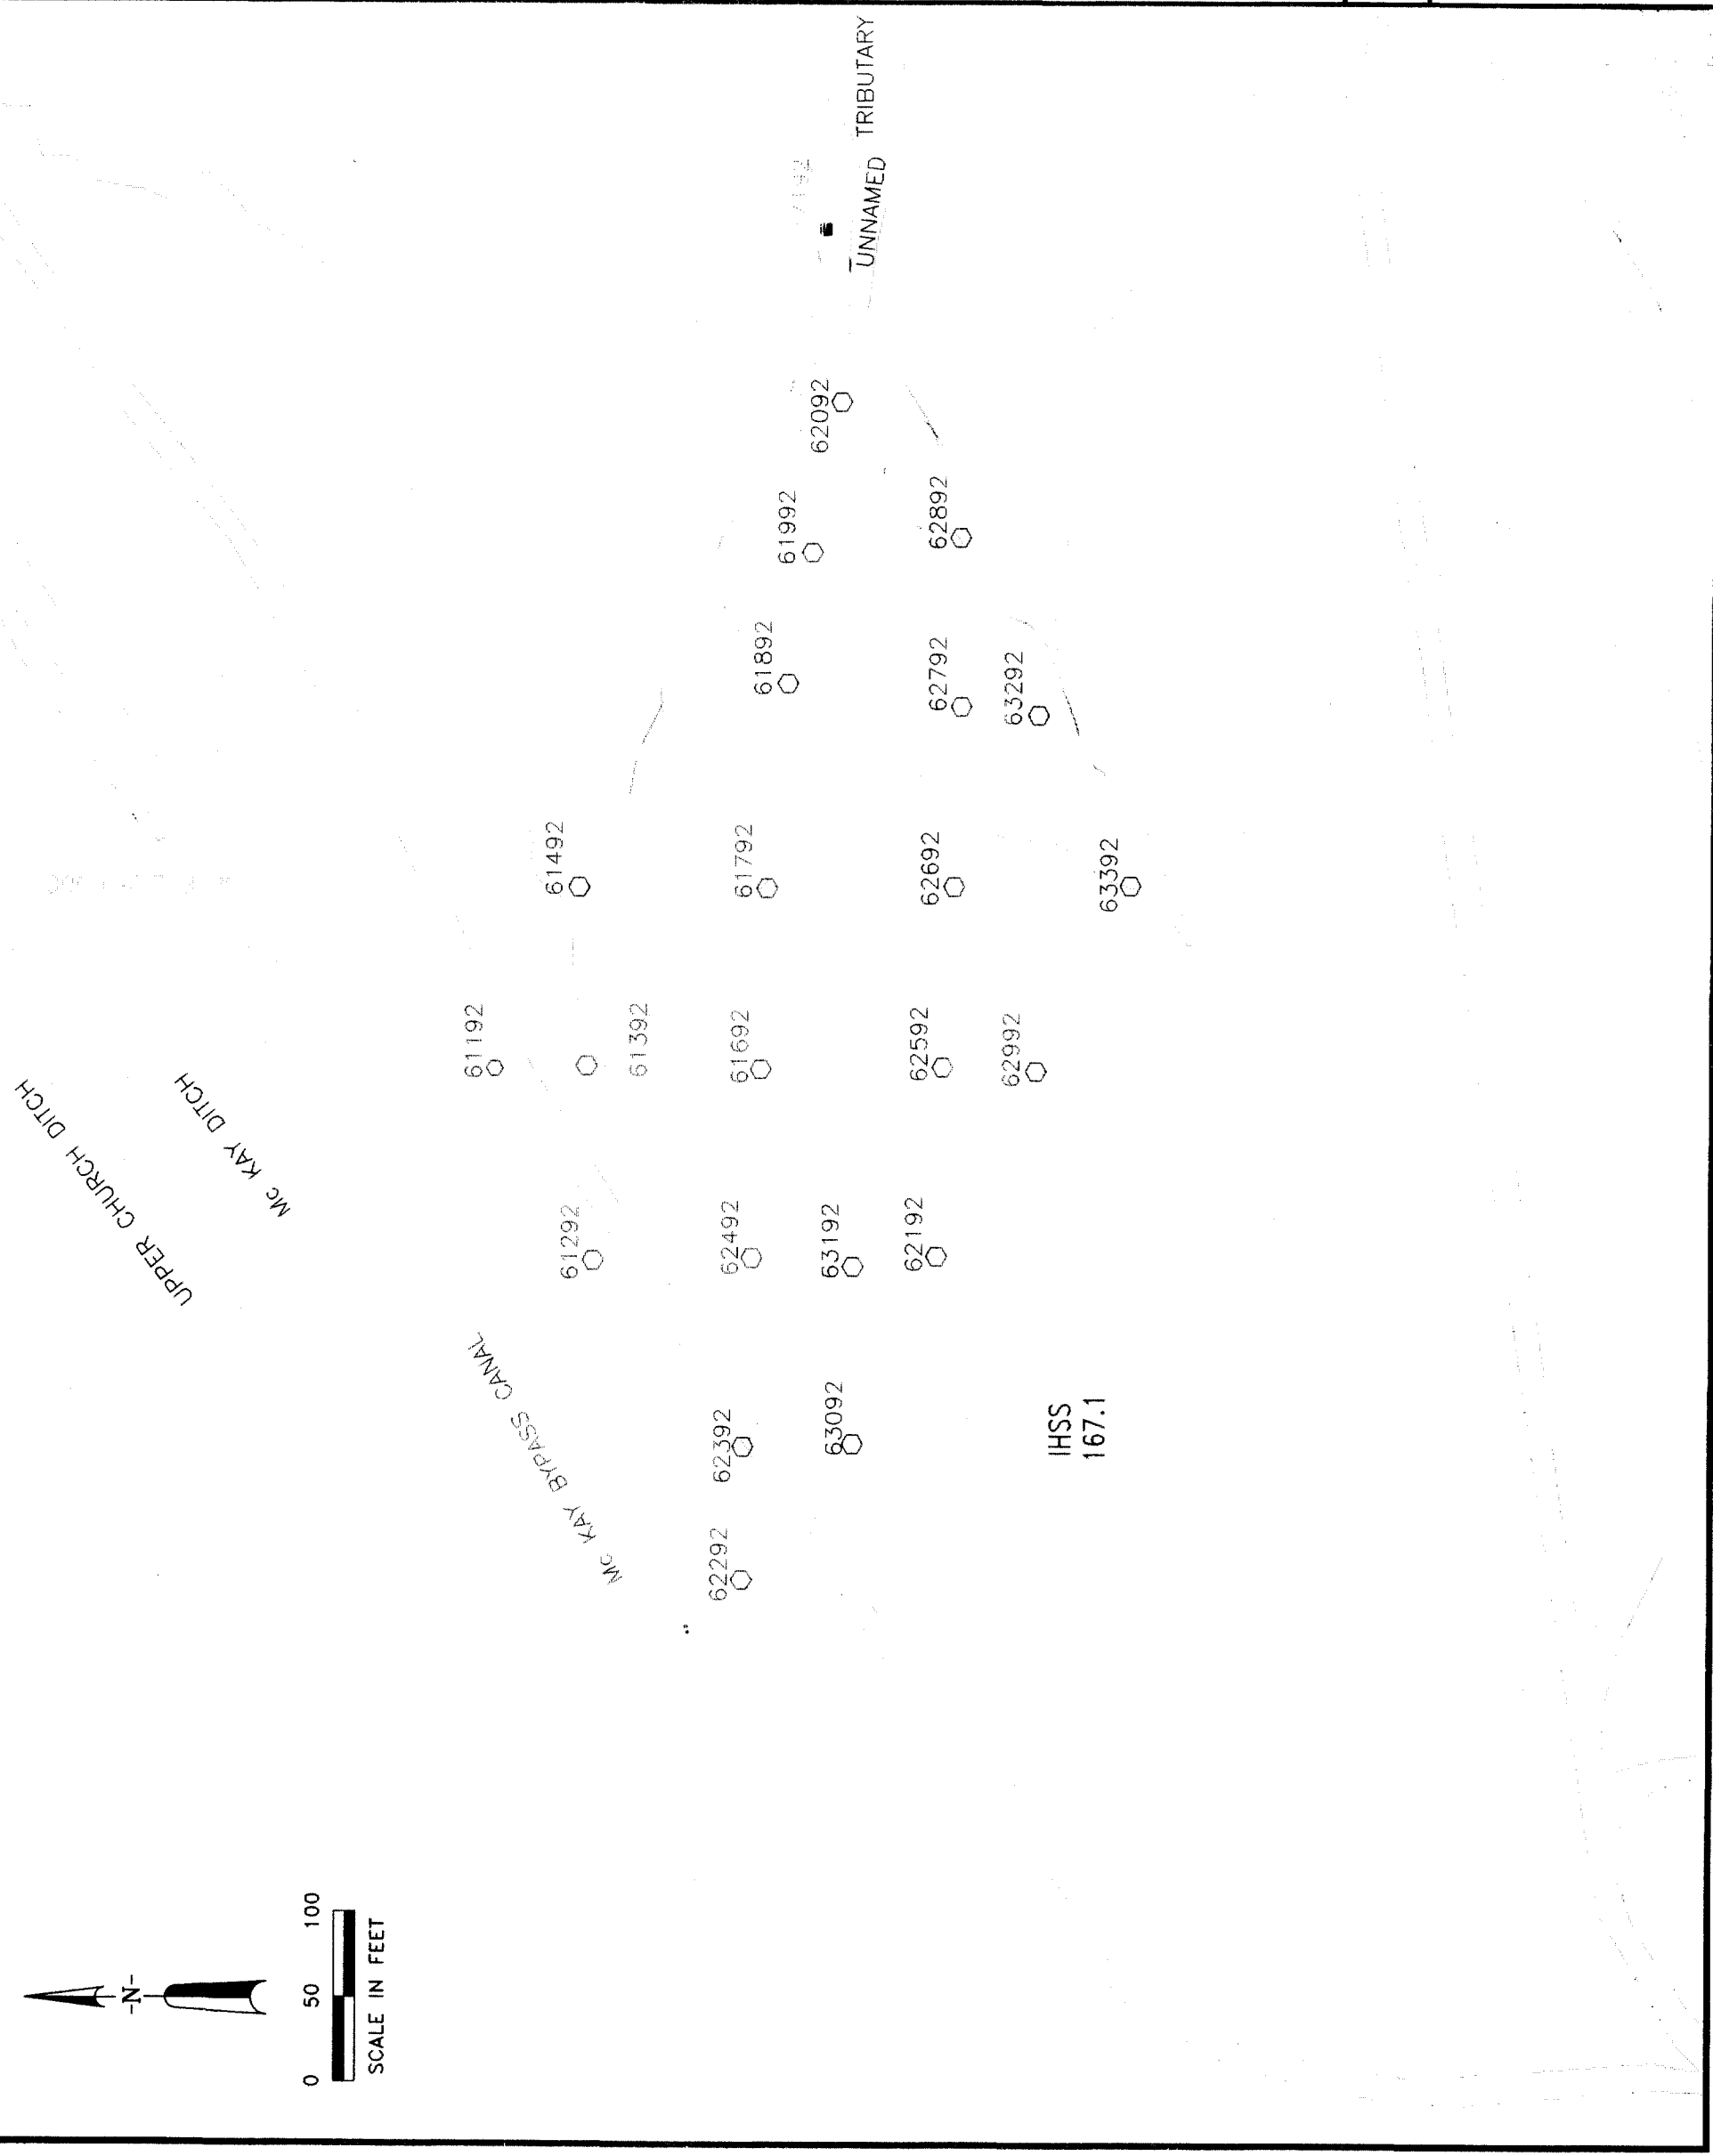
SURFACE SOIL, SOIL BORING,
AND MONITORING WELL LOCATIONS
(IHSS 167.1)

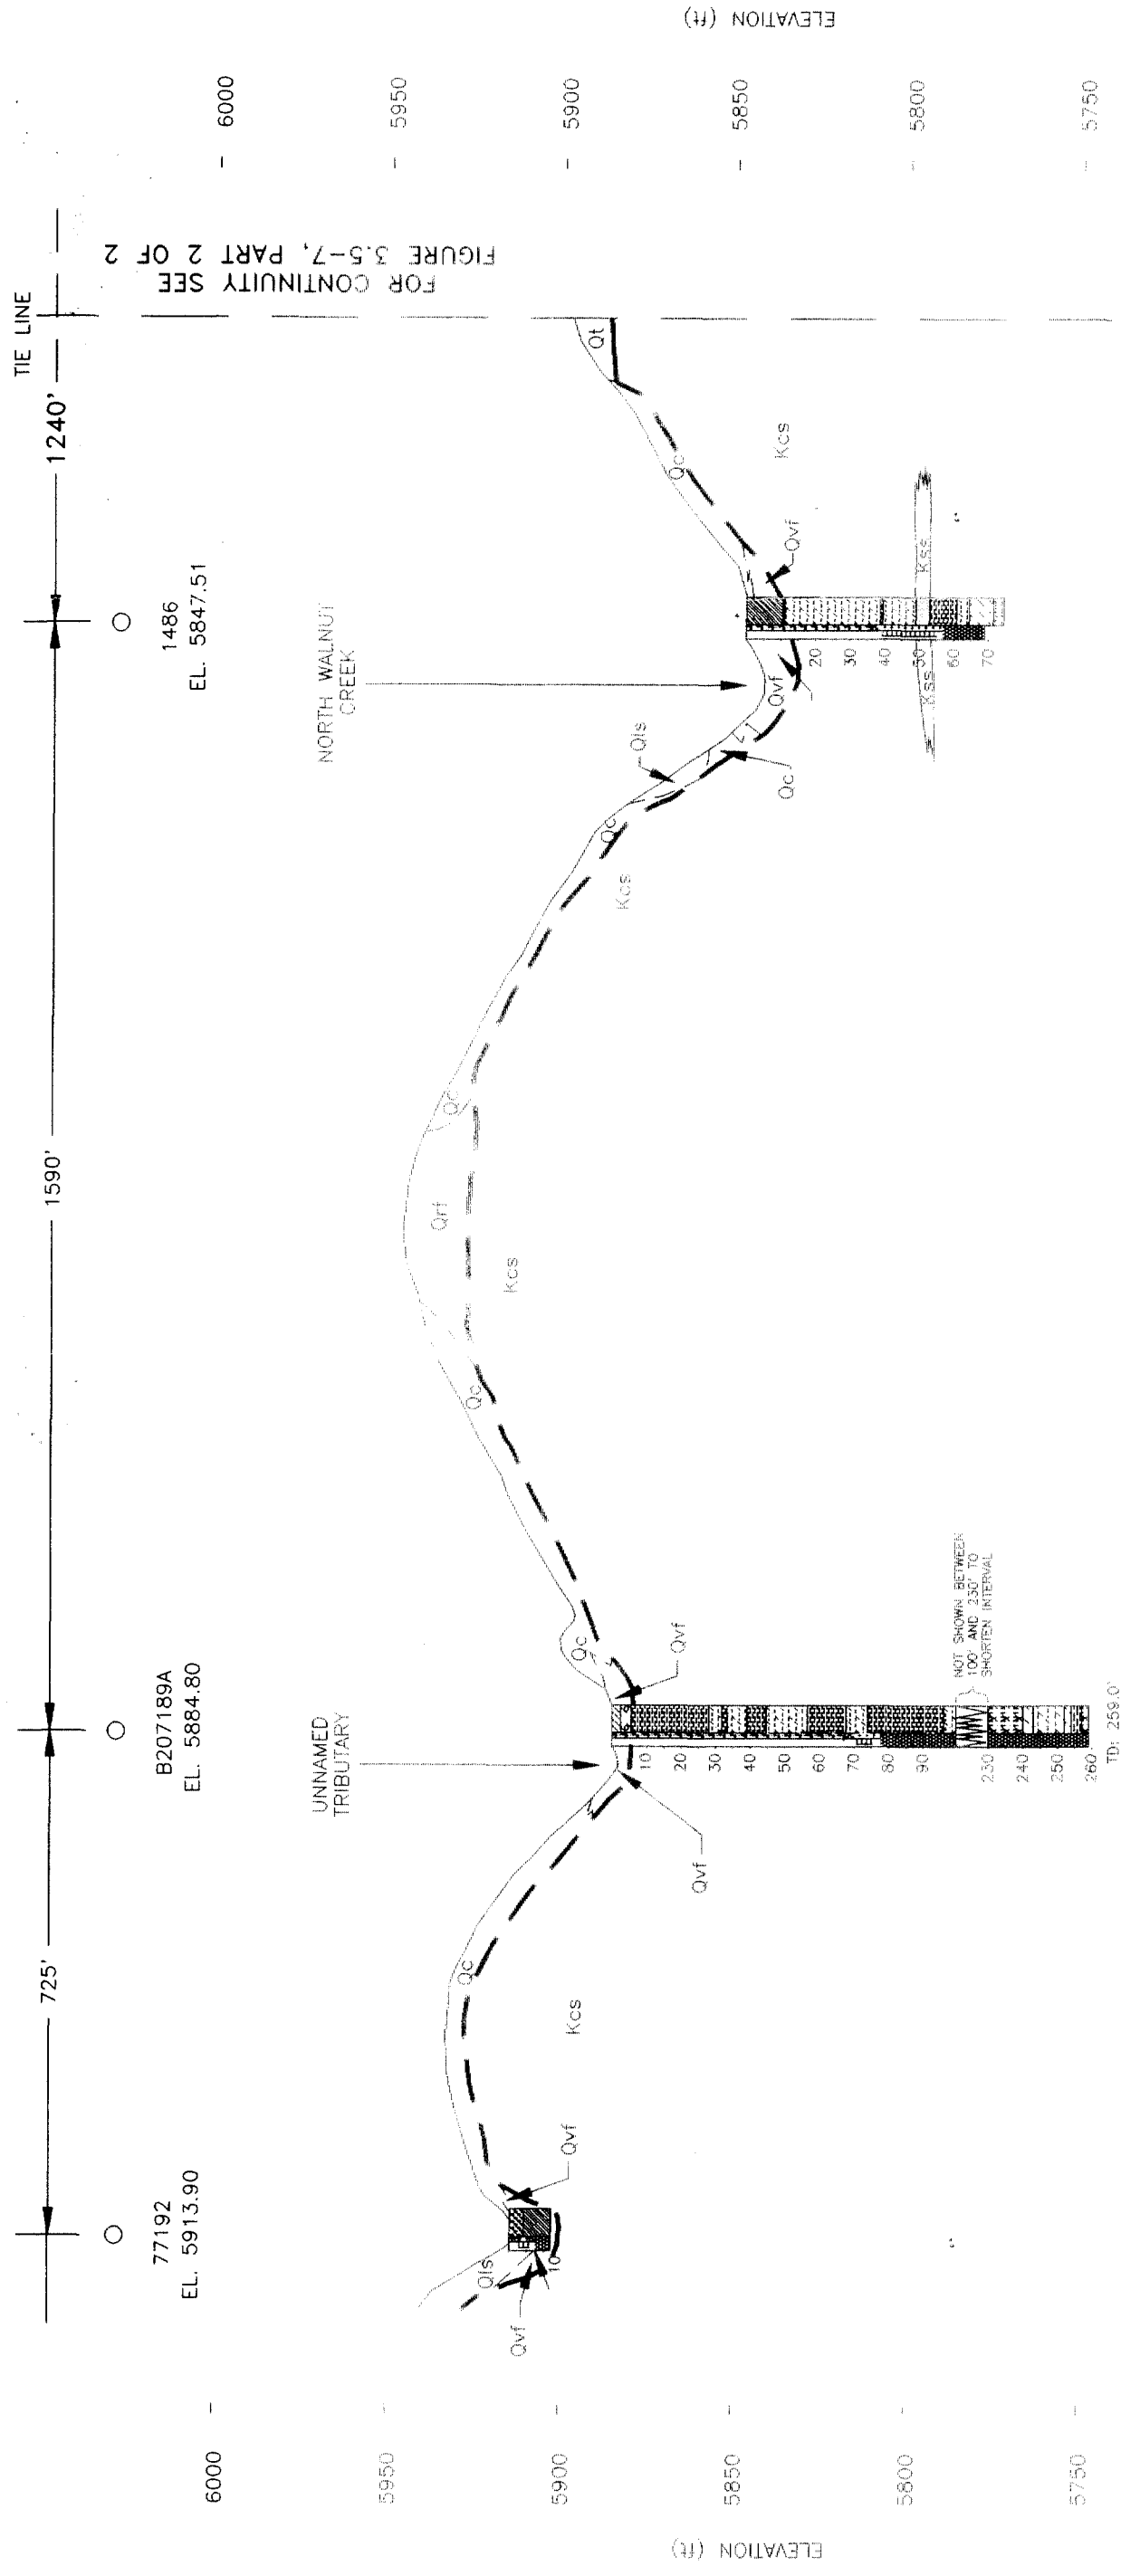
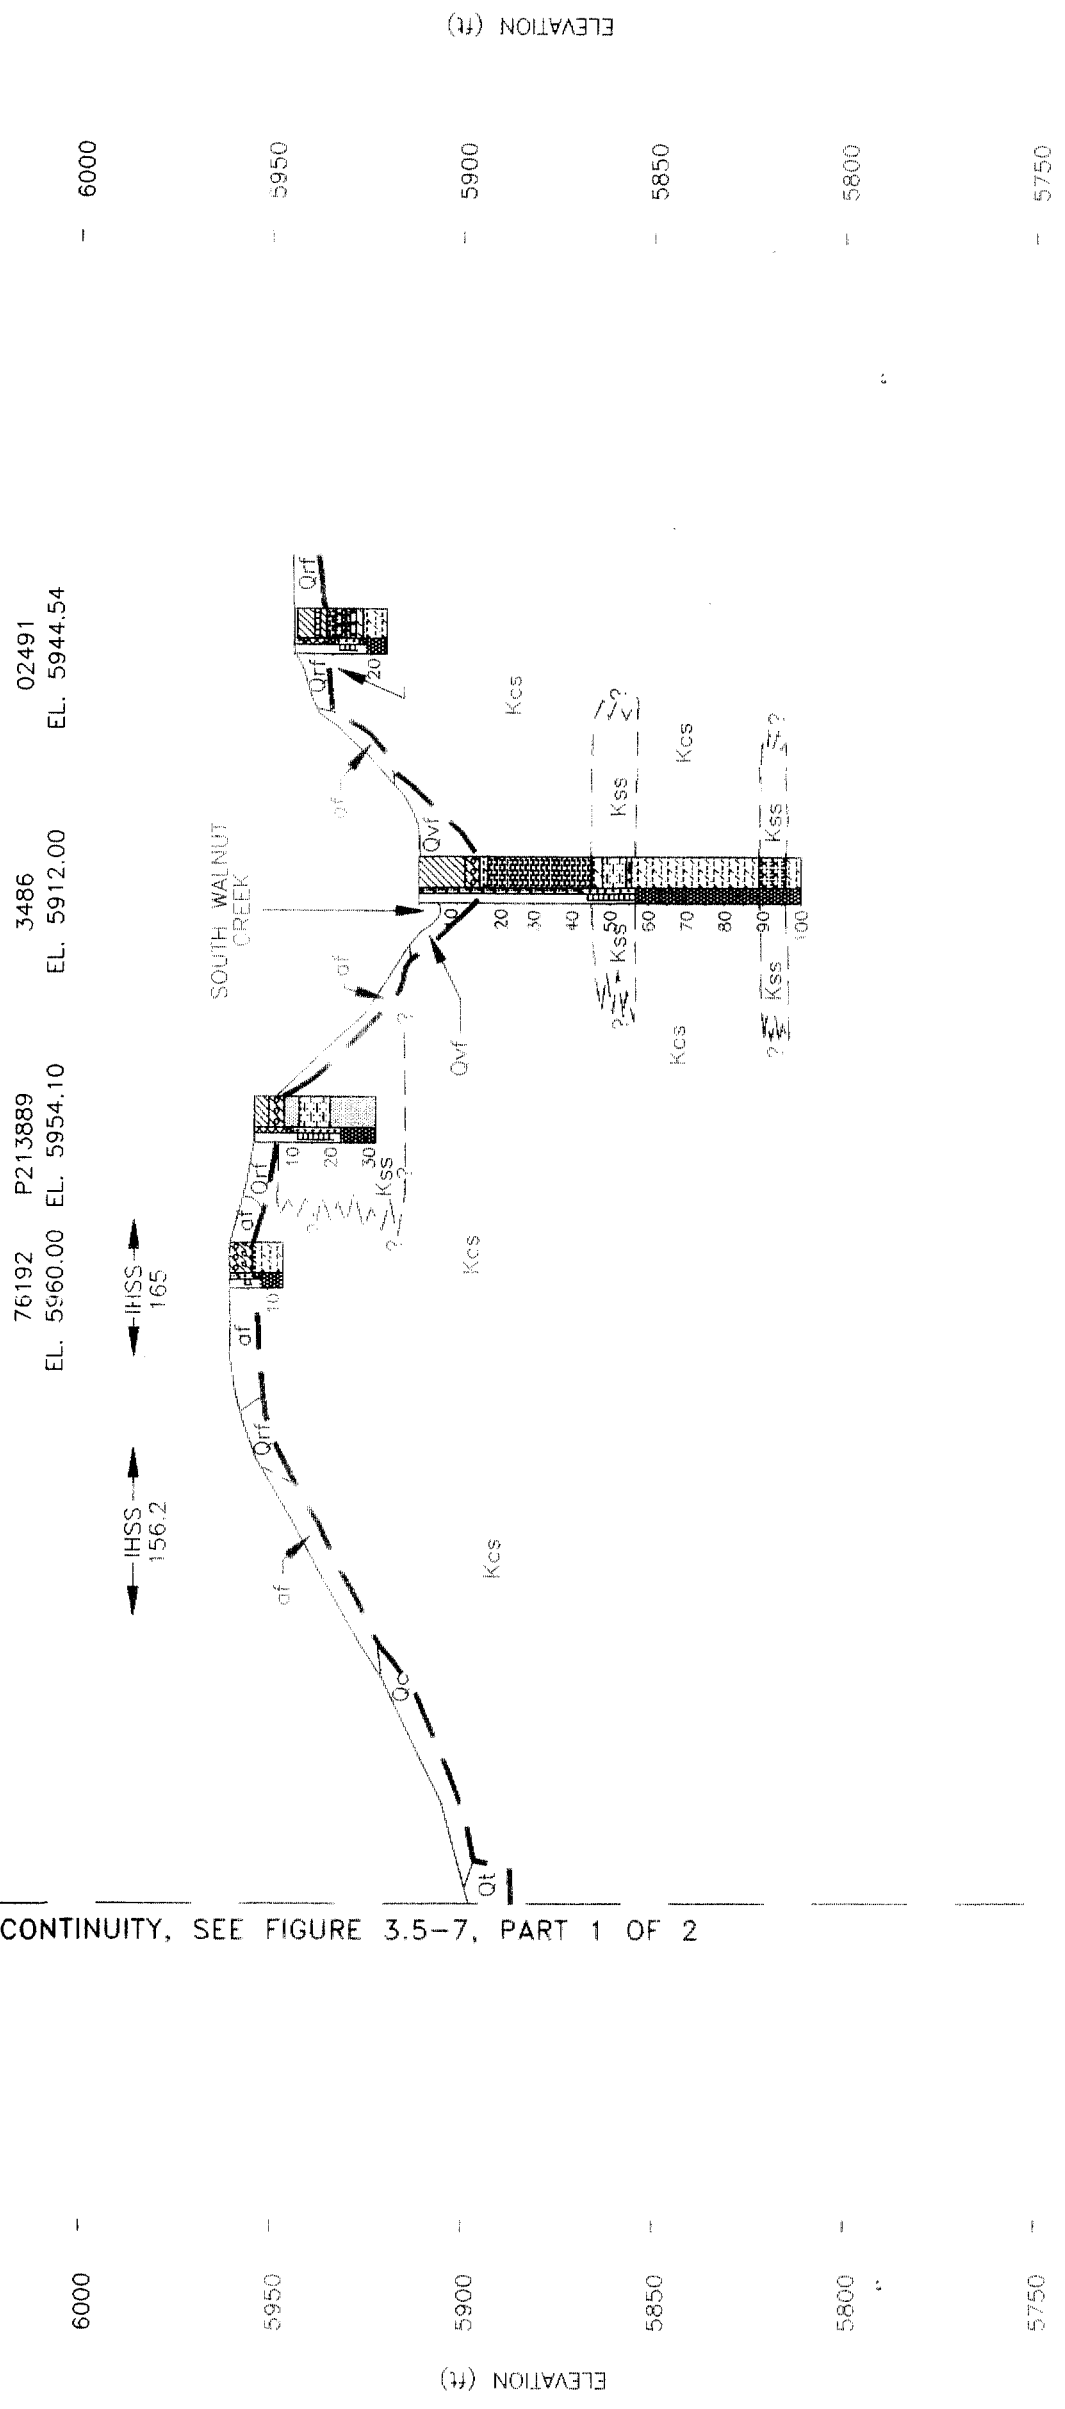
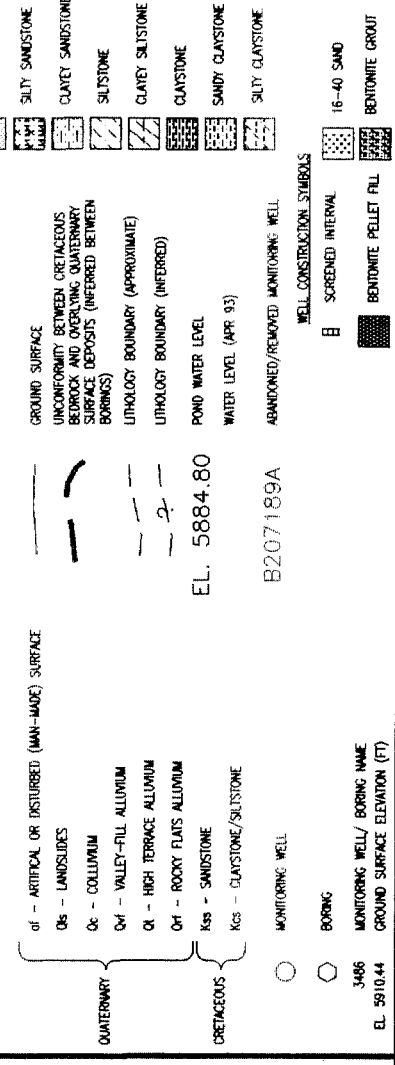
PART 2 OF 2
FIGURE 3.5-7
JUNE 1995

NOTE: Qc/Qvf CONTACT NOT EVIDENT IN WELL 1486.

NORTH - SOUTH
GEOLOGIC CROSS SECTION A-A'
TRAVERSE ACROSS THE DRAINAGES OF
NORTH WALNUT AND SOUTH WALNUT
CREEKS AND THE UNNAMED TRIBUTARY

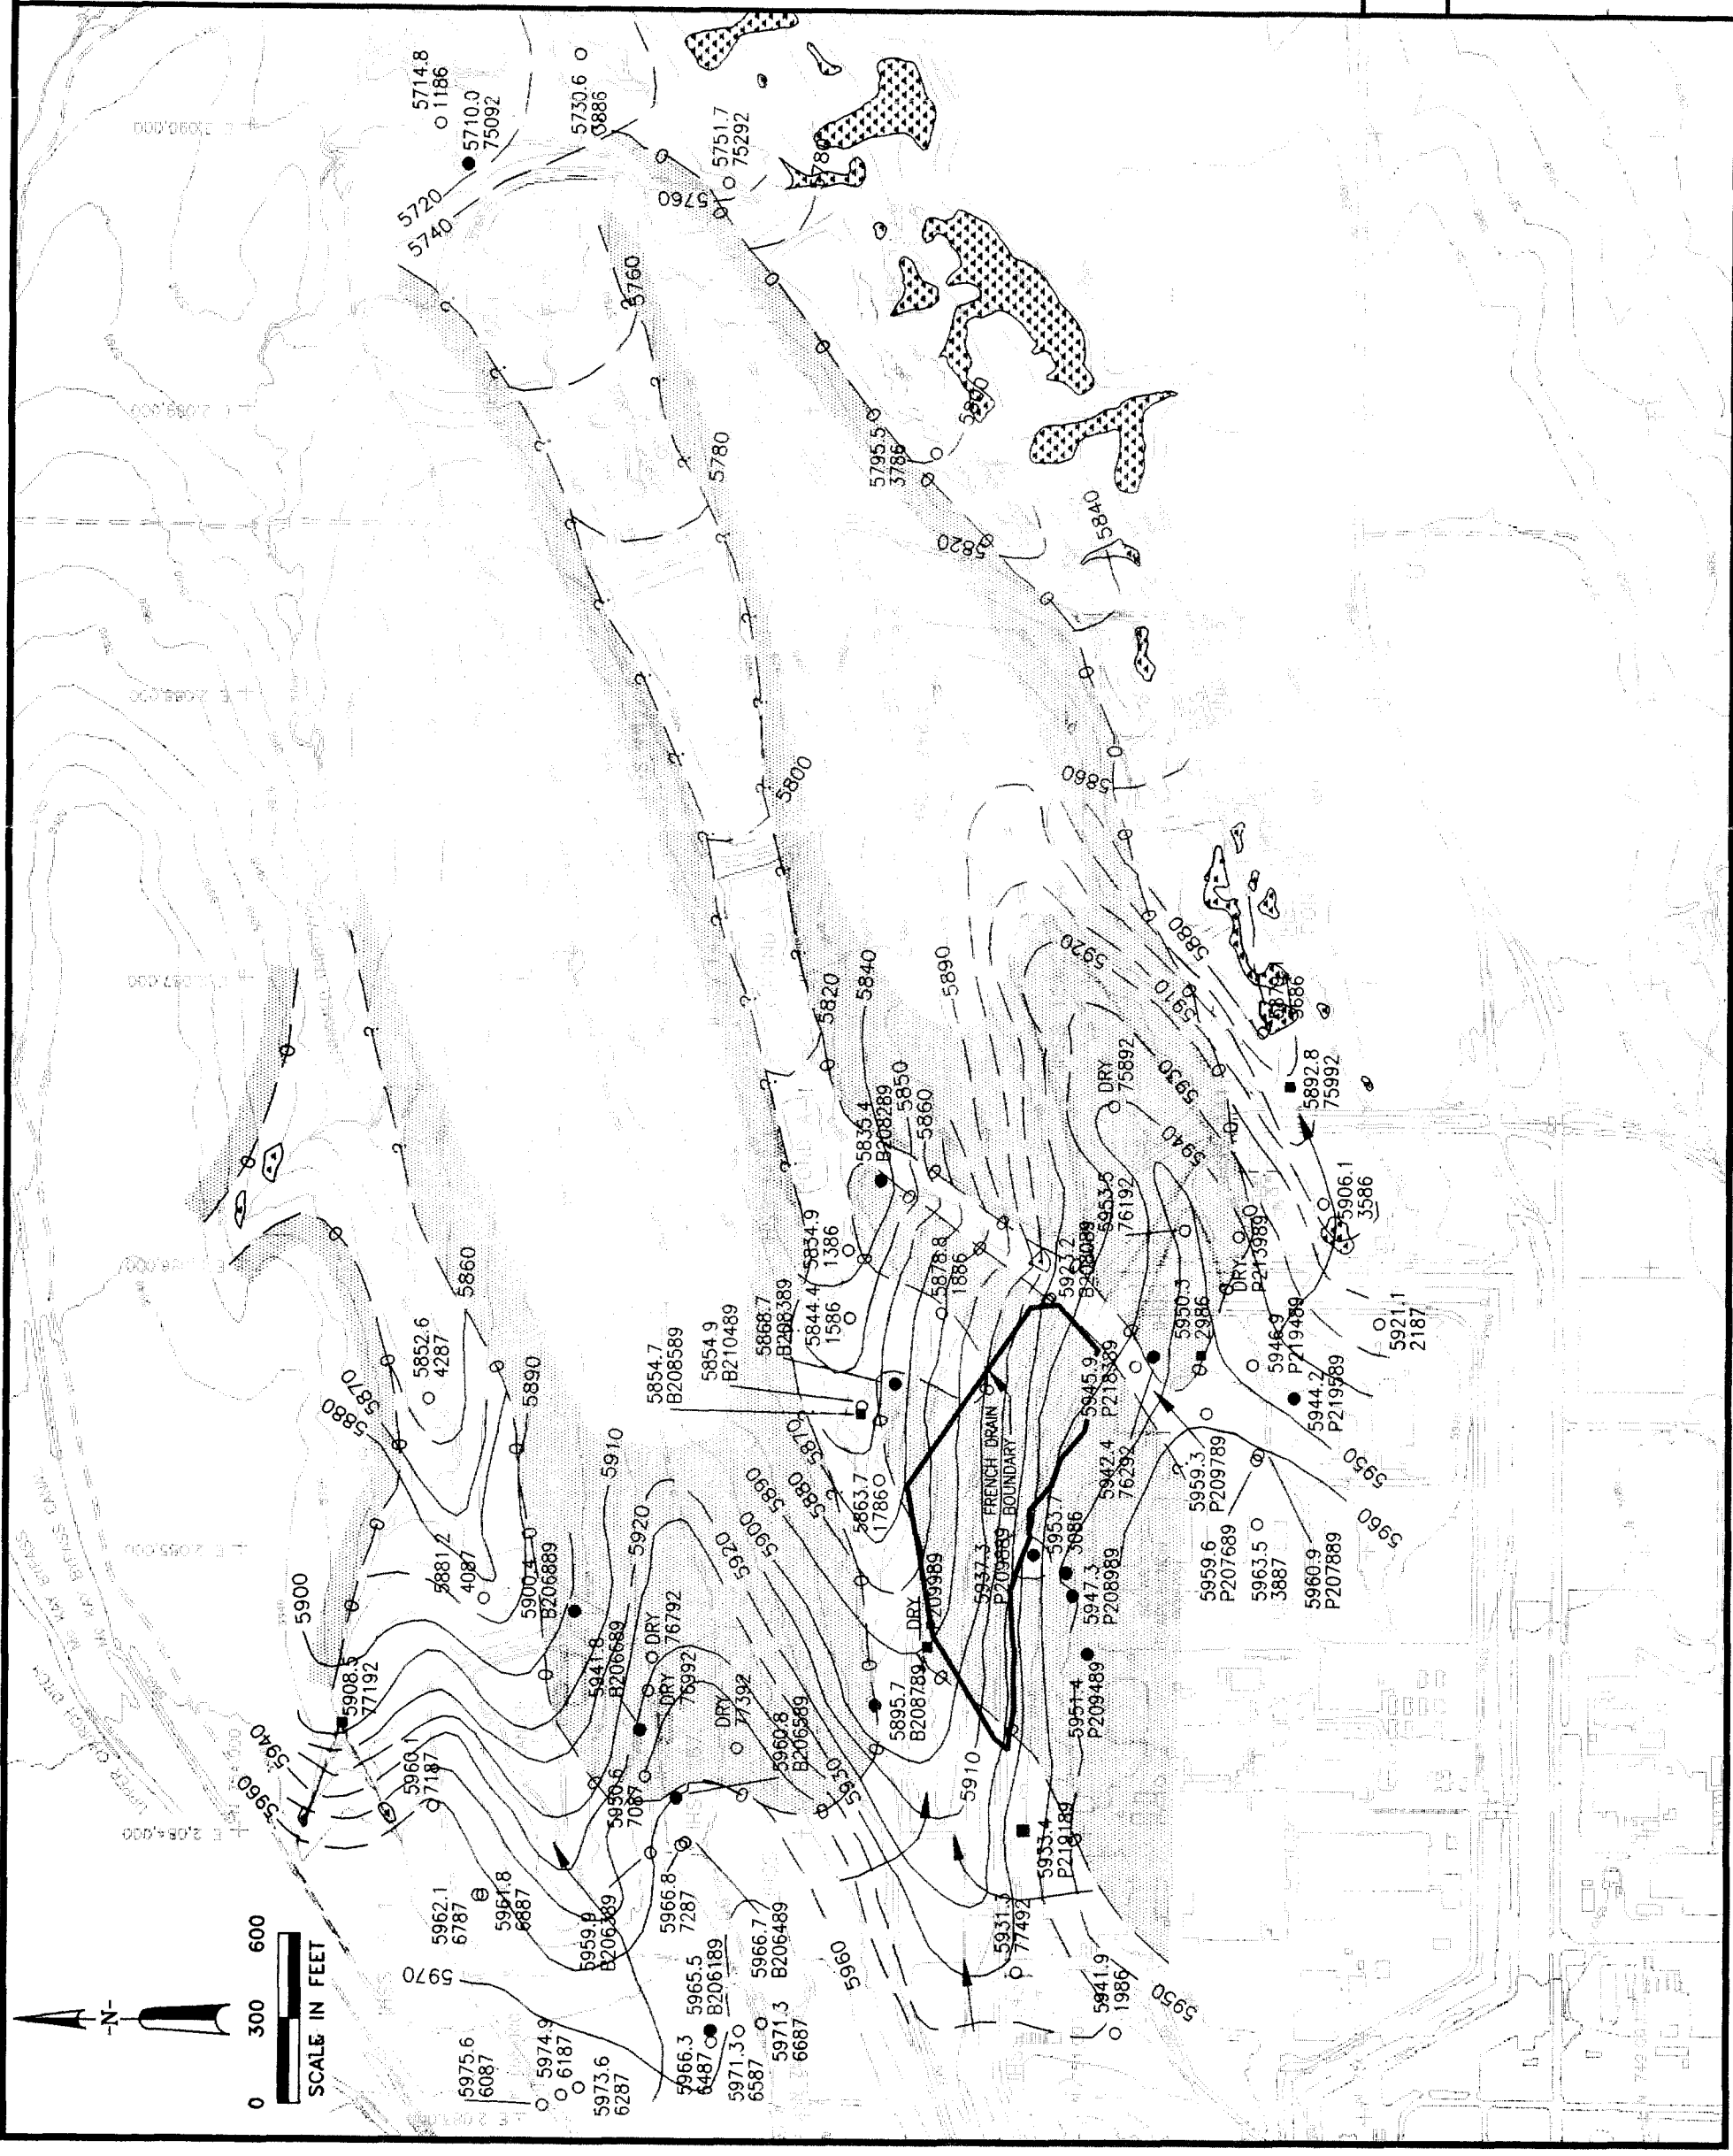
UPPER HYDROSTRATIGRAPHIC UNIT
POTENTIOMETRIC SURFACE MAP
(APRIL, 1993)

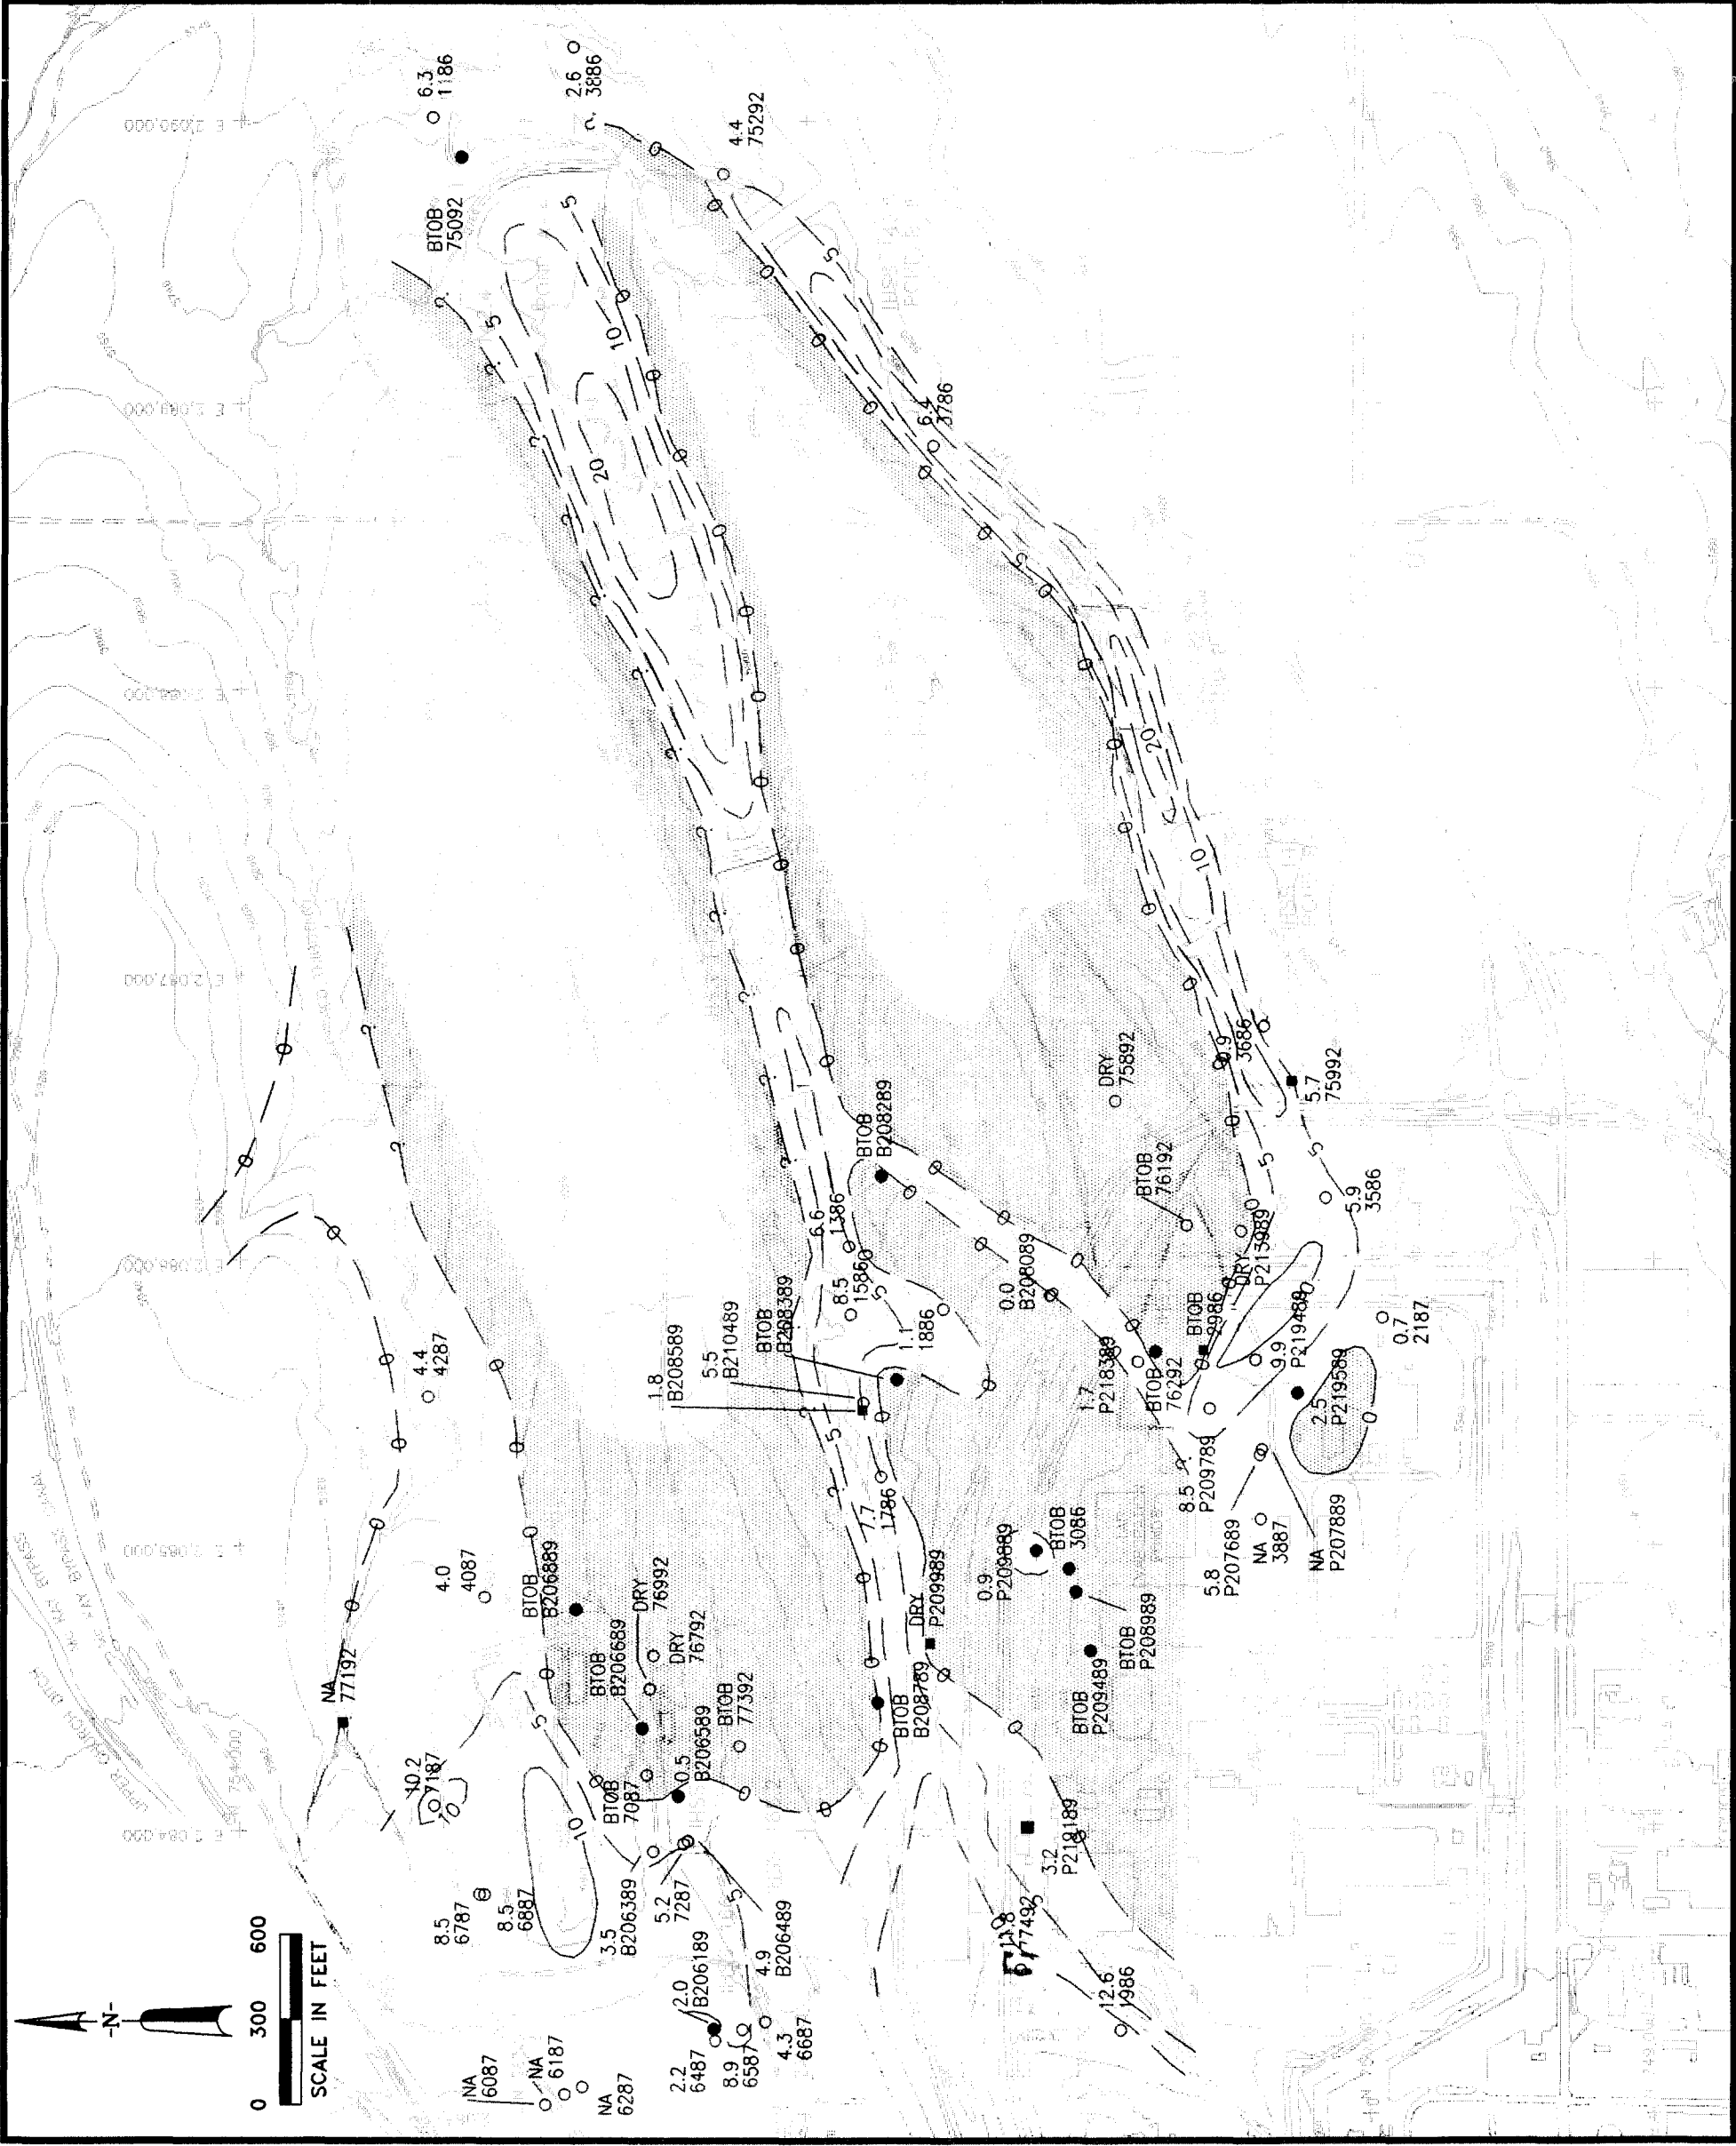
- USHU BEDROCK WELL
- ALLUVIAL WELL
- COLLUVIAL WELL
- UNSATURATED SURFACE (UNCONSOLIDATED) MATERIALS ZONE
- 5 — LINE OF EQUAL SATURATED THICKNESS; DASHED WHERE INFERRED
- CONTOUR INTERVAL (CI) = 5'
- NOTE: POND WATER ELEVATION DATA (FIGURE 3.6-1) USED FOR CONTROL IN VICINITY OF PONDS
- 0 — LINE OF ZERO SATURATED THICKNESS OF SURFACE MATERIALS (? WHERE EXTRAPOLATED)
- IHSS LOCATION WITH IHSS NUMBER INDICATED
- SURFACE ELEVATION IN FEET ABOVE MEAN SEA LEVEL (CI = 20 FT)
- 1.8 SATURATED THICKNESS (IN FEET) AND WELL IDENTIFICATION NUMBER
B208589
- BT08 GROUNDWATER SURFACE BELOW TOP OF BEDROCK
- NA BEDROCK ELEVATION NOT KNOWN OR BEDROCK NOT ENCOUNTERED, SATURATED THICKNESS UNKNOWN

UPPER HYDROSTRATIGRAPHIC UNIT
SATURATED THICKNESS OF
SURFACE MATERIALS MAP (APRIL, 1993)
